10 Restoration Work, Deconsecration, Abandonment

Summary 10.1 Restoration Work. – 10.2 Collapse of the Columns. – 10.3 Deconsecration. – 10.4 Abandonment.

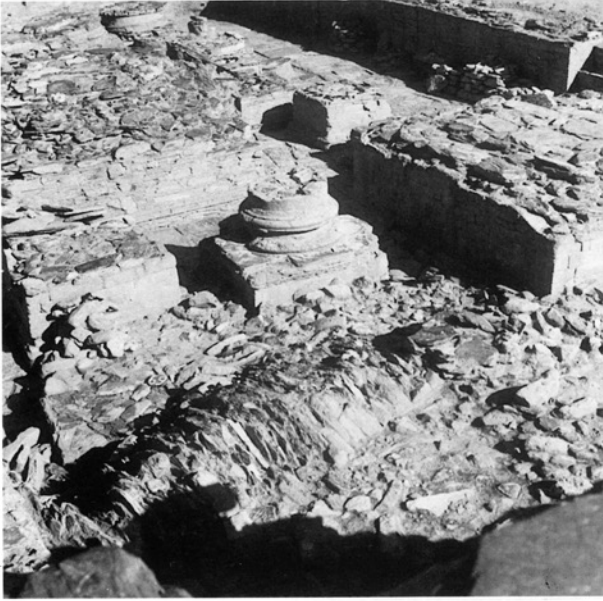
Figure 79a-b Collapse of Column C, stratigraphic evidence (= Faccenna 1995a, pl. 48)

It is interesting to observe the lie of the remains of Column C, two sections of which are to be seen. The upper section fell between monuments 13 and 16, to the north-east of the Stupa. The lower section collapsed in the SW sector, zone B, to the immediate left of the stairway. This section seems to have fallen in the opposite direction to the upper one: the former points to the west, the latter to the east. On the evidence of these two sections and their position we can advance the following hypothesis. With the collapse of the upper part, the lower part was twisted round, collapsing in the opposite direction to fall just left of the stairway (see Faccenna 1995a, pls 46-9) [figs 79-80].

When Column C collapsed it was still topped by the lion, which was in fact found in three fragments during the 2011 excavation, at a distance of about 1 m from the top disk.⁴ The upper section of Column C, collapsed between minor stupas 13 and 16, actually covered a small monument that remained hidden until excavation of the column in 2011-12. The monument, of which only the base of the podium has survived, and which appears in the numbering as 100, lies a little to the east of 13 and 16. The monument was totally shattered by the collapse of the column, only the first courses of the podium remaining. It proved difficult to make out the phasing of the pavement of monument 100 when Column C collapsed since the rammed earth floor of the terrace had been disturbed by the previous excavations, frequent cleaning and exposure to the elements.⁵ In any case, the springer of 100 seems to correspond to the level of the springer of 13 and 16, and therefore to belong to the final phases of period I. The pavement phase on which Column C collapsed (covering 100) has however been identified as corresponding to F2, i.e. the period III pavement of the stupa terrace.

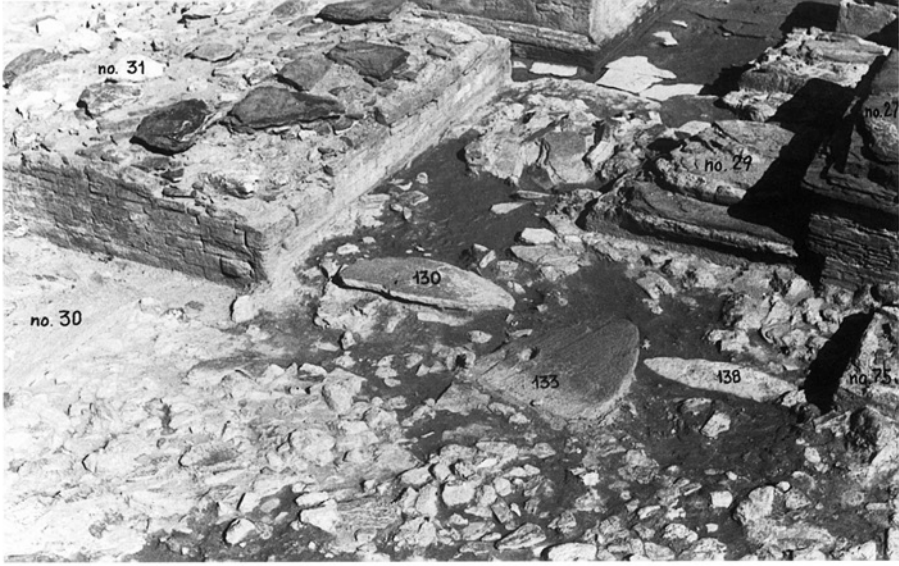
Figure 80a-b The demolition of the Frieze, stratigraphic evidence (= Faccenna 1995a, pl. 288)

However, the Frieze had already been scattered by then. I will conclude this study with an account of what we know of the fate of the Frieze. Some of the panels collapsed and were found at the base of the podium, in particular on the east side, also under the remains of the lower section of Column C, in sector NE/B, to the left of the stairway. Most of the fragments must have been moved there, deliberately brought together, both in sector NW/A of the excavation (to the right of the Stupa stairway) and in sector NE/B (to the left of the stairway), which was excavated in 2011-12. From there the specimens by the least worthy of the sculptors following in the steps of the earlier masters were taken to patch up the masonry of the shrines and minor stupas for which no better treatment was reserved (Faccenna 1995a, pls 288-96).

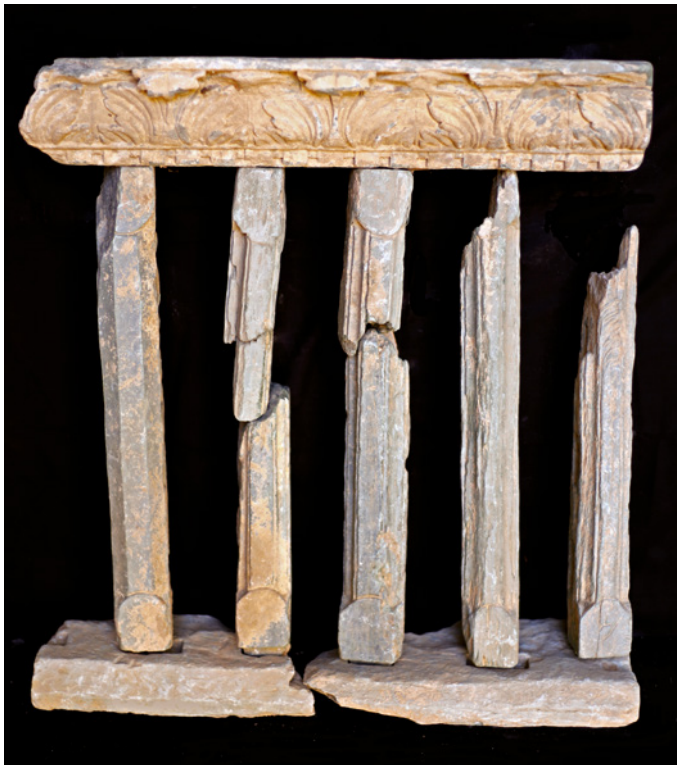
Figure 82 The assemblage of the false railing (MAIP; photo by Luca M. Olivieri)

Towards the end of period I the Frieze was certainly readjusted. There were problems with both the false railing and the figured panels, which, as we have seen, were not sufficiently stable. Significant evidence of this is to be seen in the re-adaptation of elements of the cornice and base of the false railing, reused as cornice and base of the panels. The tenon sockets on the pillars were adjusted to fit with the panels. This is a delicate point, we have already discussed it; I add here that if the false railing had been detached because it had partly collapsed, the Frieze would also have had static problems. Obviously for Faccenna this problem does not arise because in his reconstruction the Frieze was at the bottom. Having considered that this was not probable, I also believe that at the moment the false railing collapsed, the detachment phase of the Frieze also began. This event must be later, certainly towards the end of the second century. Elements of synchronism of the two episodes can be deduced from the simultaneous reuse of elements from the Frieze and the false railing. For the former: fragments of the Frieze are in the core of the podium of shrine 63 (period II, phase a = second-third century); for the latter: a small pillar is found in the core of the podium of shrine 36 (period II, phase b = second-third century). Towards the end of period II (and in the third century) plundering had started on the podium facing in talc schist blocks, which were reused in the restoration of other monuments, creation of small new structures in the stupa terrace, and even in some parts of the Monastery.¹ Thus we may picture the scene; restoration work continued on the minor stupas around it while the great Stupa at the centre fell ever deeper into decline or, better, was gradually demolished, taken to pieces to 'feed' its architectural *minores*. The mind turns the story of the previous life of the Buddha in which, as prince Mahāsattva, he fed the tiger and its cubs with his body (there are more *jātakas* with a similar moral). Perhaps there is no better end for a stupa.
