The Armenian-Italian Joint Expedition at Dvin Report of 2021 Activities

Abstract This paper aims to show the preliminary results of the first excavation campaign at Dvin/Dabil (Armenia), conducted by the Italian-Armenian research group in Autumn 2021. The excavations involved two areas in distinct sectors of the city. While the Armenian team re-opened the investigation in the so-called Market, the Italian group opened a new digging area in the south portion of the citadel, the South Tower area. Preliminary documentation of the material contexts and laboratory analysis of ceramic samples were included in this mission. Chemical analysis of pottery aims to define the origin of the raw materials used and, hopefully, provide some information about the places of production.

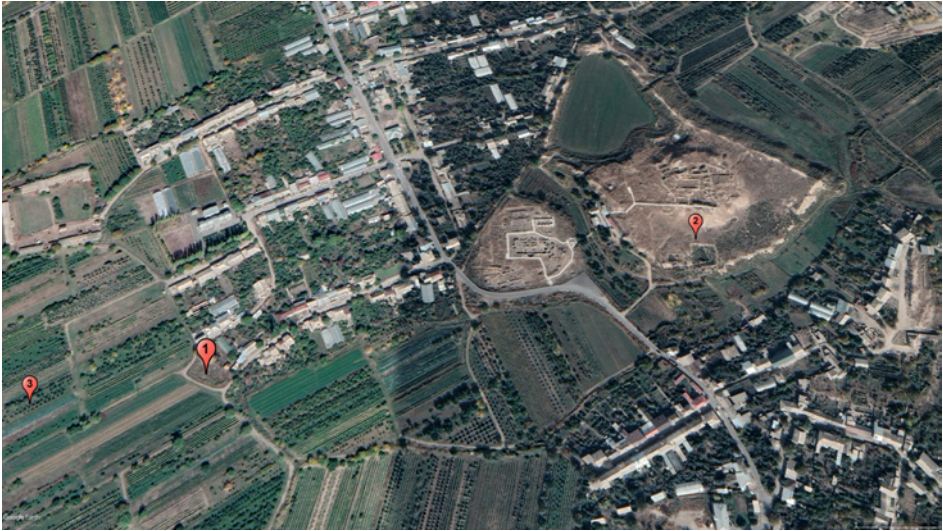
Figure 1 The area of the monument with the indication of the excavation sites of 2021

The excavations concentrated on three sites [fig. 1]: 1) the area called 'Dvin Market' (4th site), where archeological excavations begun in the 1950s were left incomplete; 2) the south-eastern part of the Lower Fortress, where the Italian team initiated stratigraphic excavations in an area of 5 × 5 square metres (area 1000); 3) exploratory excavations were carried out about 200 metres south of the market in a residential-economic complex opened during a tree planting in the garden of one of the villagers.

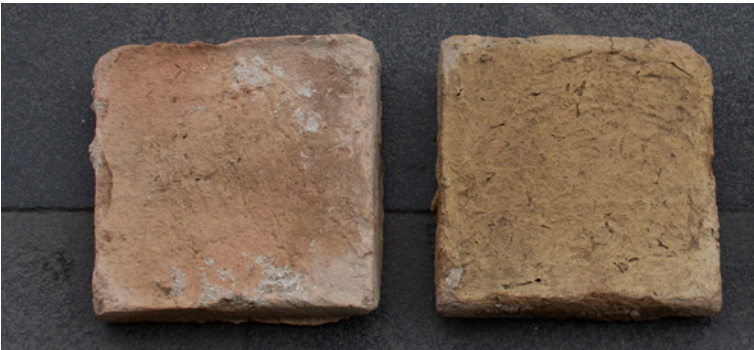
Figure 5 Complete bricks discovered during the excavations of 2021

The total number of findings from the 2021 excavations is 1,760. All of them are approximately square, almost the same size (23.5 × 22.3 × 5 cm [fig. 5]), yellowish and pink in colour. There are only two fragments that bear fingerprints. Small pieces of gypsum decoration were found [fig. 24]. In other cases, the bricks are flat and do not have patterns or signs. Two fragments of refractory stamped bricks were found in one of the garbage wells. The brick is modern, but the stamp has not been deciphered yet [fig. 25]. The main mass of simple and glazed pottery originates from the upper excavated layers and belongs to the 12th-13th centuries. The fragments of ordinary pottery are made of white clay [fig. 26], and the fragments of glazed vessels are covered with green and three-coloured glasses: green, yellow and brown [fig. 27]. It is still difficult to date the structure or any part of it via glazed pottery. It should be noted that the last flourishing of the city dates back to the 12th and the first half of the 13th century, and glazed pottery from that time is abundantly scattered throughout the city.

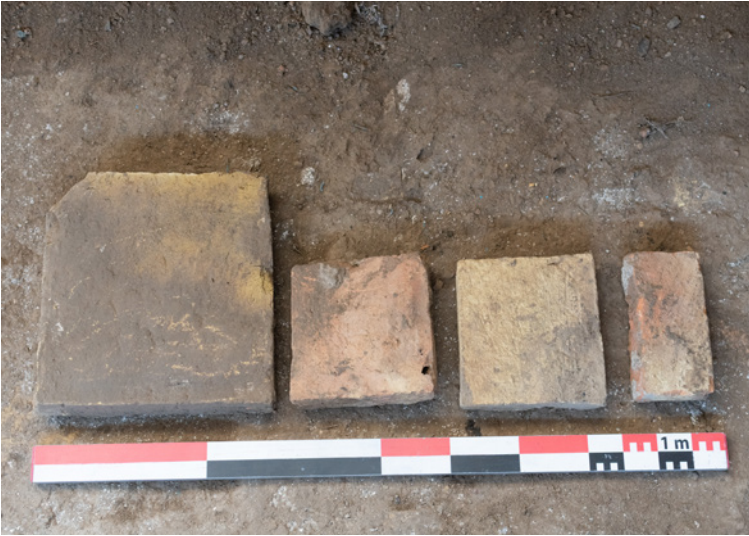
Figure 6 12th-century bricks from the excavations of the structure at the western foot of the Citadel

split bricks ($17.5 \times 17 \times 5$ cm in size, [fig. 6]). Let us add that the widespread use of burnt bricks in Armenia is attested at least since the 2nd century AD (Kanec'yan 2015). The initial impression is that the market bricks are closer to the early medieval findings. Hopefully, further excavations and subsequent physico-chemical analyses will provide data for a more accurate dating.

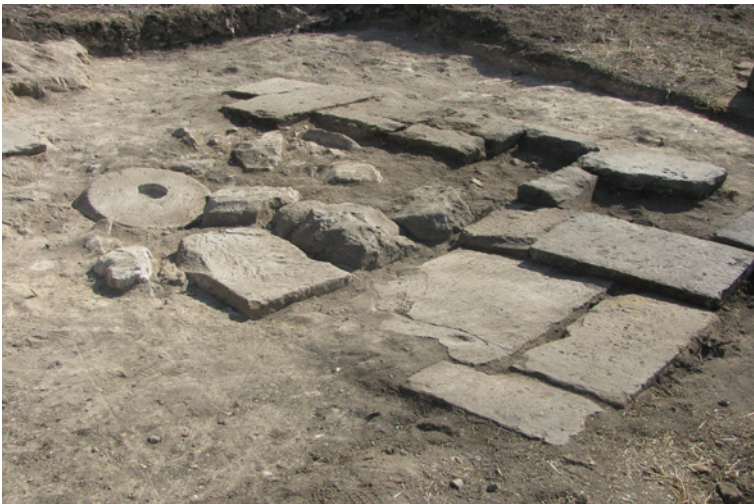
Figure 10 Paving section in the eastern part

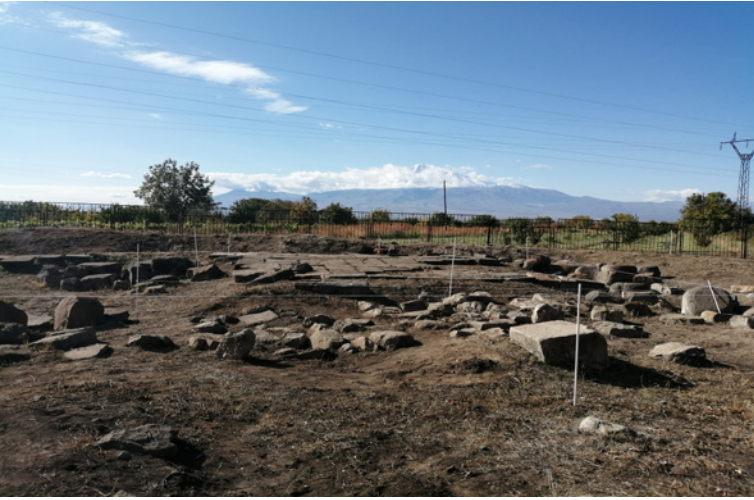
Figure 13 The paving of the western part after cleaning

First of all, in the central part of the excavation, the floor in the highest position was exposed (B3-4, C3-4 squares, about 80 square metres [fig. 13]). The opening of stream-holes in both parts of the pavement is especially noteworthy. This feature is not reflected in the previous plan. The northern stream-hole (length 2.20 m, width 14-15 cm,

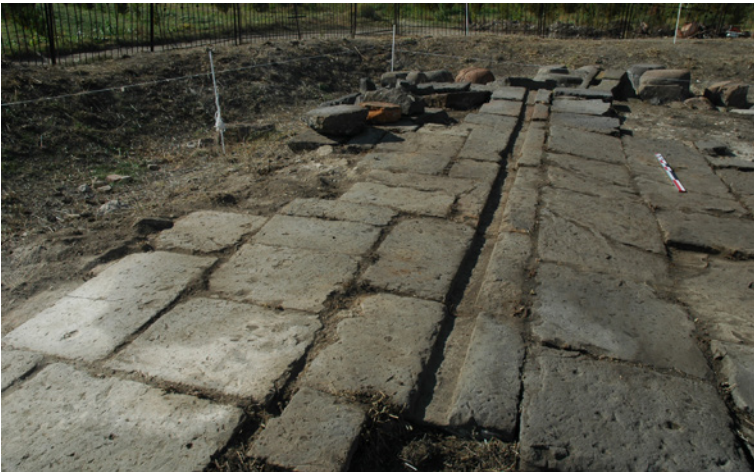
Figure 14 The stream-hole passing through the centre of the western paving

depth 6-8 cm) has an interruption, which is probably a result of the reconstruction of the pavement. The southern stream-hole (length: 6.45 m, width: 14 cm, depth: 6-8 cm) definitely belongs to the original structure. Here, the paving was built with the water-channel in the longitudinal axis [fig. 14]. Such reclamation channels have been identified in medieval caravanserais (Selim, Haržis, Alnjajor), in the stables built near monasteries (Havuc' T'ar, St Sargis of Ošakan, Amaras) and in the barns of medieval villages (Ernjatap'). In our case it was probably located within the area of the building and likely had a sanitary-hygienic function.

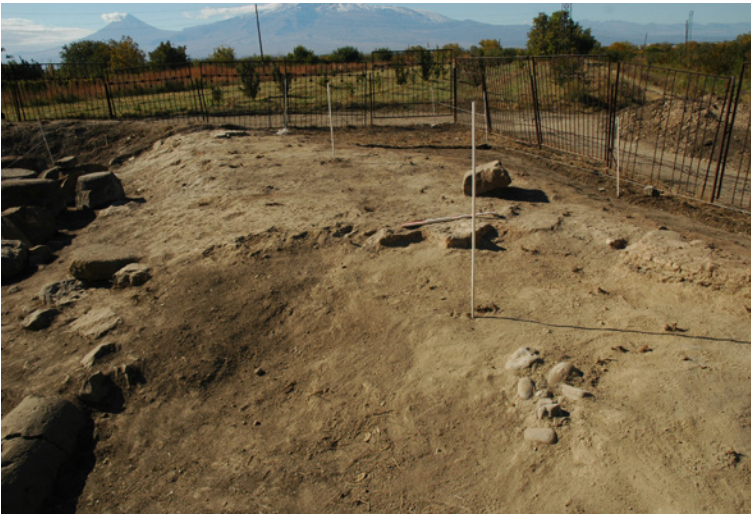
Figure 15 The lime concrete platform of the western wall and the arrangement of bricks

After unearthing the paving, the excavations concentrated in squares A1-2, B1-2, C2, D2-4, at the level created by the collapse of the western and southern walls. Here, excavations of certain sections of the collapsed and excavated wall in the western part revealed horizontal layers of lime concrete and rows of burnt bricks placed in a horizontal position [figs 15-16]. The incision made in the southern part of the wall resulted in the laying of bricks, which were somewhat dilapidated as a result of further excavations, but placed in horizontal rows [fig. 17]. Some whole bricks were also found here. These findings also confirm that we are dealing with a stationary wall. It should be noted that that part of the southern side of the excavation is not marked on Karo Łafadaryan's map, while on his plan he marked a wall in the western part, which does not exist at present. It is possible that the wall was demolished by the residents after the excavations in order to remove bricks. In the southern part (square D4) at a depth of 0.75 m, the base of a wall with an oval layout was uncovered. It was lined with rough boulder blocks and lime concrete mortar [fig. 18]. From the outside it is covered with lime concrete plaster [fig. 19]. This is a very important piece of evidence in favour of the opinion that we are really dealing with a solid plaster wall that prevents the penetration of moisture. A slightly ruined wall branches from this wall to the paving [fig. 20]. We can assume that we are dealing with the entrance to the structure, but this assumption must be explored and clarified during the next excavation season.

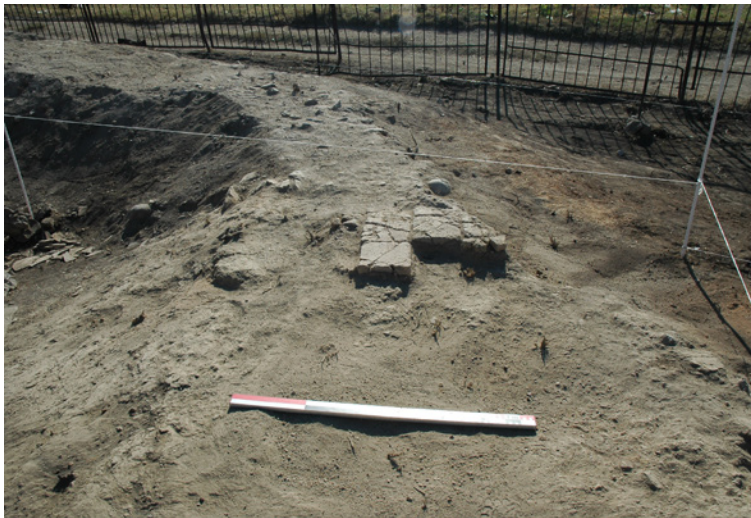
Figure 16 The south-western corner of the brick wall

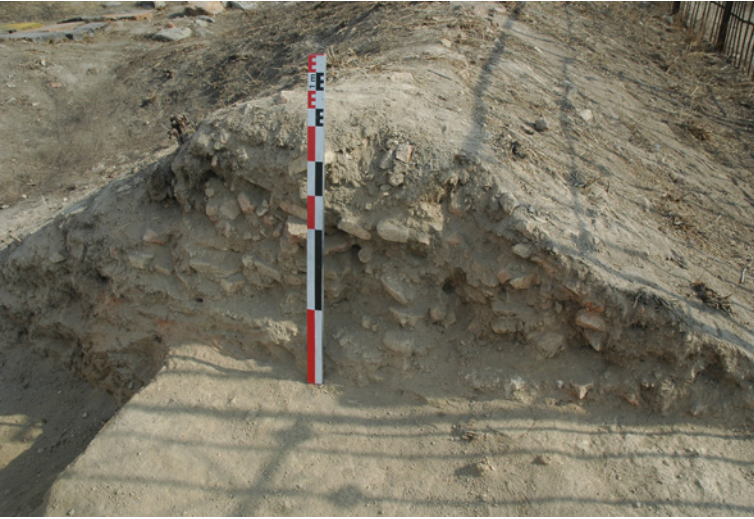
Figure 17 The section of the southern wall

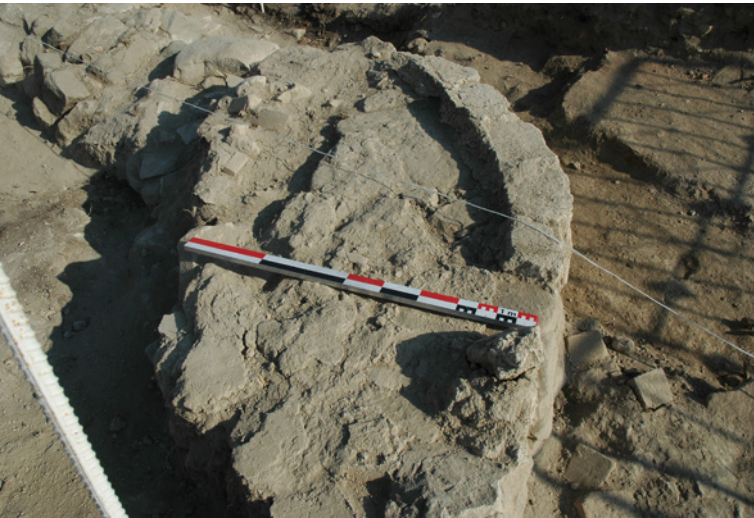
Figure 18 The oval part of the base of the southern wall

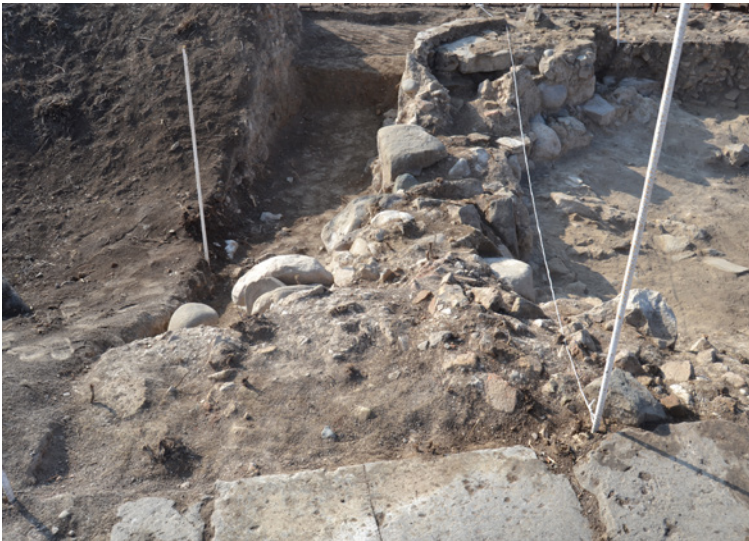
Figure 20 Remains of a wall leading from the oval section to the paving

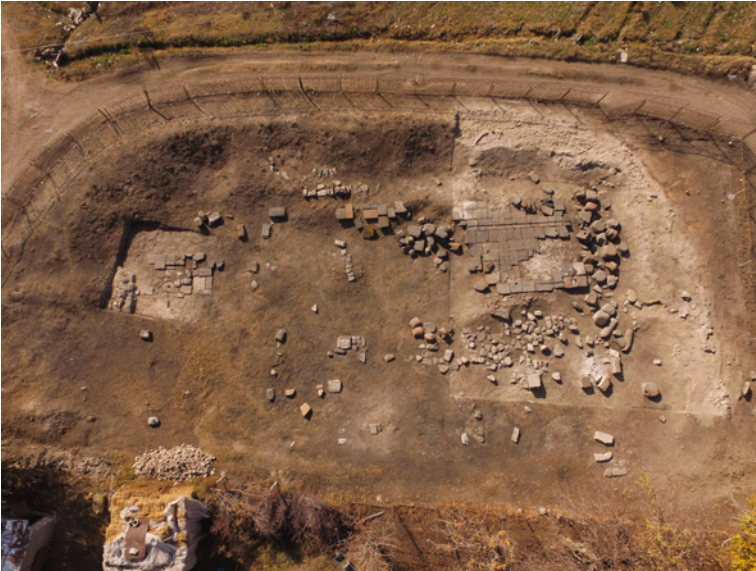
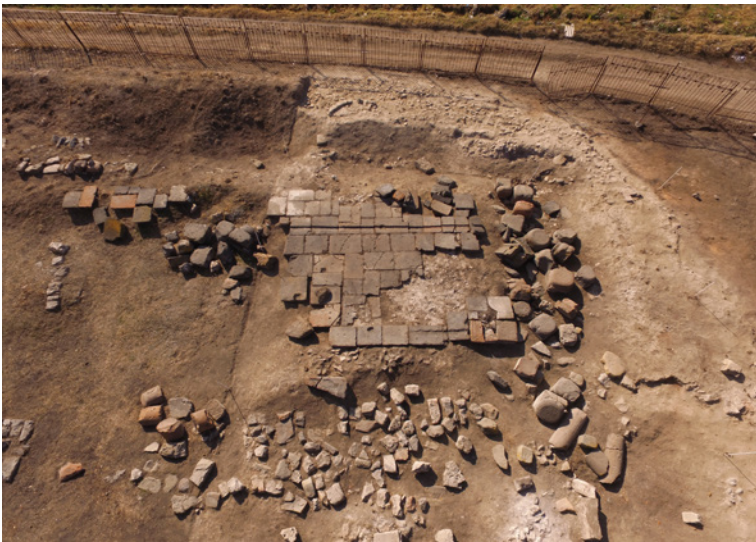
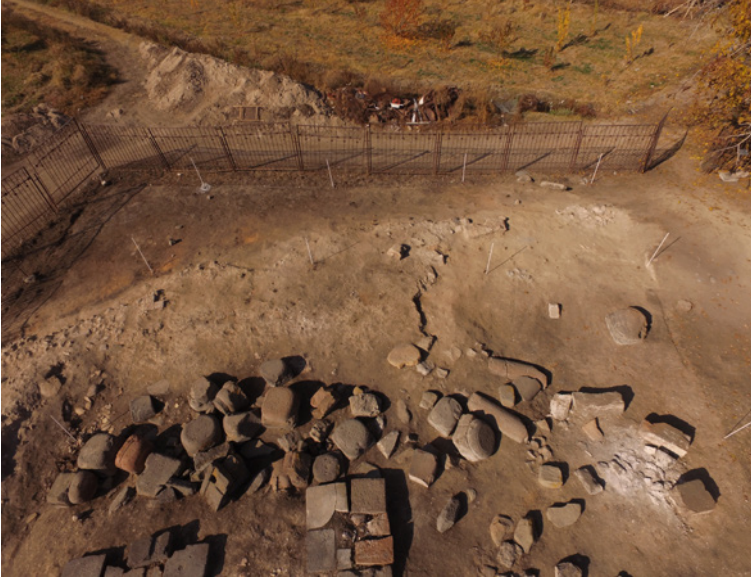
Figure 21 Overview of the market at the end of the 2021 excavations

Figure 22 General view of the southern edge of the market at the end of the excavations

Figure 23 The general appearance of the western edge of the market at the end of the excavations

To sum up, the architectural-structural situation revealed through the excavations of 2021 [figs 21-23] allows us to propose the following preliminary hypothesis: that the original structure had rich interior architectural solutions (tuff polished paving, tuff polished anchors, columns, caps). It also had burnt brick walls rising on a stone and lime foundation. It should be noted that the 5th-century Catholicos's Palace excavated in the central district of Dvin had a similar internal structure and layout (three rows of tuff anchors arranged in two rows). These are more massive type anchors decorated with triangular protrusions. The market with its volumetric and sculptural solutions was surrounded by a wall made of raw brick, and the floor was covered with clay (Łafadaryan, K'alant'aryan 2002, 62-5). We further

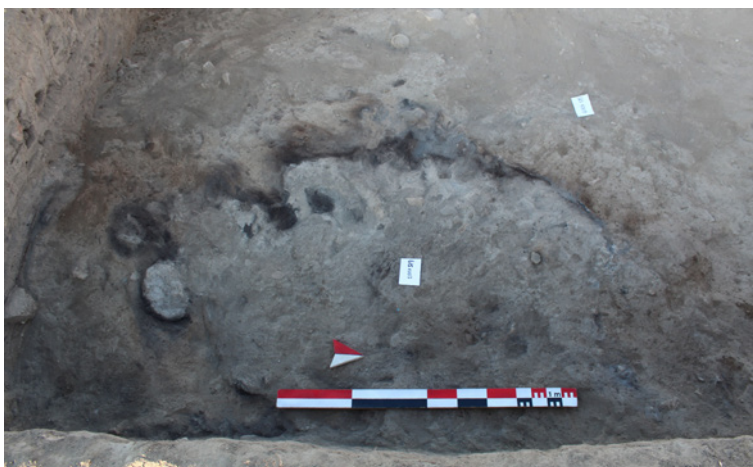
Figure 29 SU 1007, with ash and charcoal traces

The first anthropic layers were identified in the eastern portion of the square. These (SUs 1004, 1005, 1007, 1011 - **fig. 29**) were characterised by orange and dark brown/black soil with masses of ash, which clearly displays that fire was lit in the given location. Those layers had a semi-circular shape, underlined by an irregular boundary of black ash and burnt soil on the western and northern sides, while they continue under the southern and eastern sections of the digging area. Currently, we cannot identify a chronological framework for the fire, since the excavation has yet to be completed; however, we can hypothesise that it follows the phases of decline and progressive de-urbanisation of the site (second half of the 13th century according to traditional interpretations). In these layers, a conspicuous number of pottery fragments and abundant animal bones were found. These finds show burning traces only in a few cases. After a preliminary analysis, the ceramic context seems to refer to a timeframe between the 12th and 14th centuries.

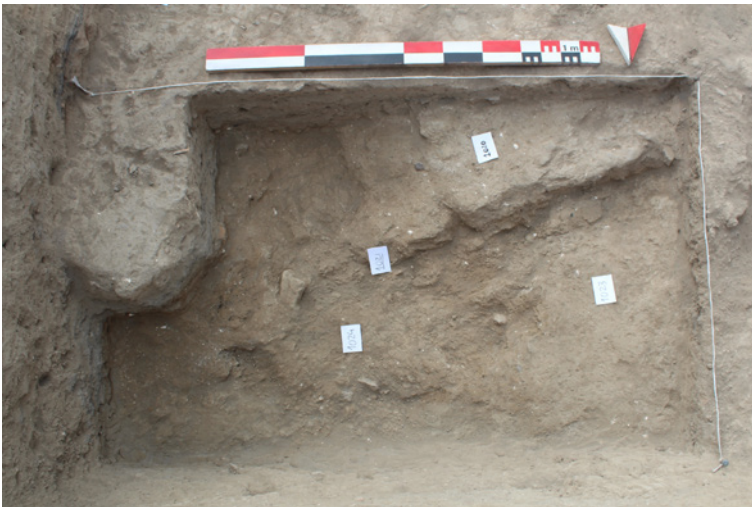
Figure 31 Sample in NE corner of Area 1000

In order to clarify the function and composition of SU 1010 - the northern portion of the ground level - and to obtain the widest stratigraphic column for this season, a small trench of 1.50×1 m was made at the NE corner of the digging area [fig. 31]. Immediately under SU 1010, a small portion of an ash layer (SU 1018) with frequent little fragments of charcoal, lumps of mortar and pottery fragments

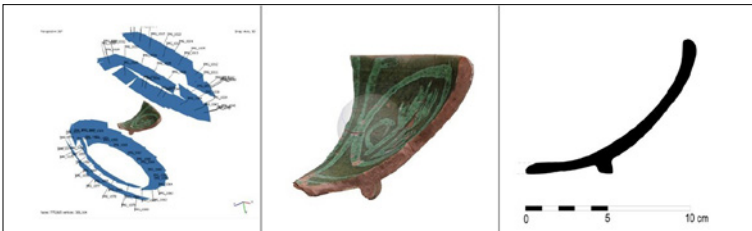
Figure 33 Photogrammetric survey process and 3D modelling of pottery from Area 1000

During this field season we selected all the materials to be sent for archaeometric analyses. All the sherds were documented photographically. Moreover, a photogrammetric survey was applied to each fragment that helps identify the shape of the original pottery article. This last step is crucial for carrying out a metric survey and a 3D model of each piece [fig. 33]. The next step is to complete the documentation of the fragments by calculating the IMN (Individual Minimum Number) of each typology found thus far.
